A series of trials and investigations were carried out at the Church as part of the Development Phase of HLF funded repair works at the Church of St Mary Abbotts Ann.

This report describes the findings during:

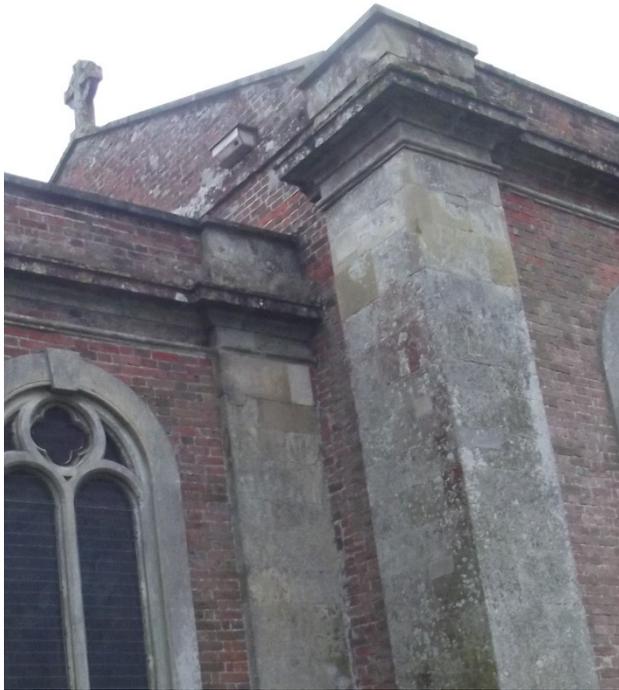
5.01 Site of Stonework Trials

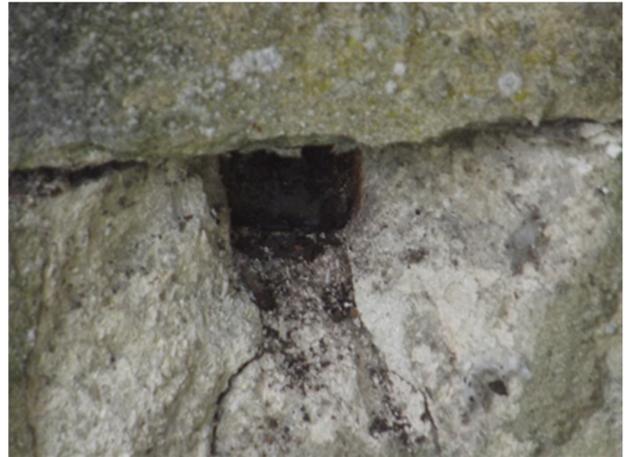
The removal of the cement patch revealed the head of a ferrous cramp set into the stone joint. The schedule will include for all such patches to be removed and the cramps replaced using stainless steel.

5.02 Iron cramp exposed below cement fill

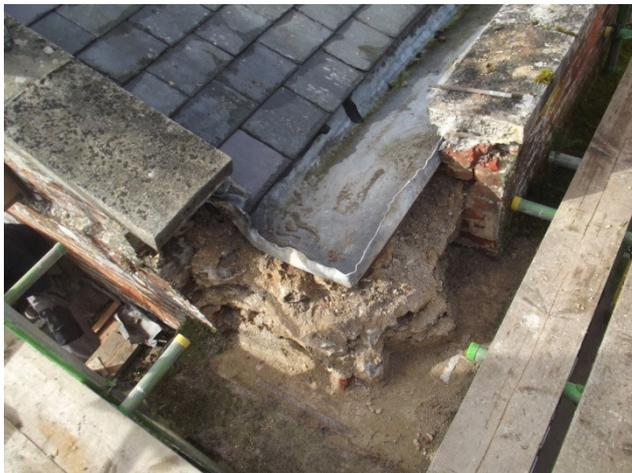
Removal of the parapet revealed the top surface of the cornice. The projecting stones are cramped together with ferrous straps approximately 75mm back from the face of the parapet. They are set in lead which has fortunately protected them and there are no signs of corrosion-induced cracking or failure in the cornice. They were treated before the parapet was reconstructed over them.

5.03 Section of Parapet dismantled (cramps in cornice)

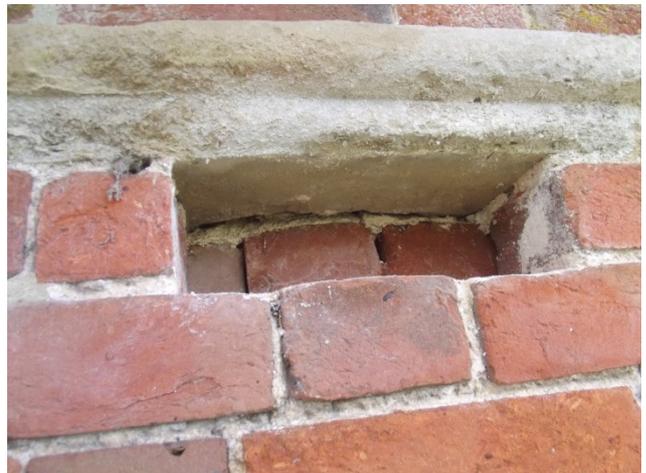
The removal of the adjacent brick revealed that the roll moulding was bedded in the wall for half a brick's depth. The mortar around the roll moulding is the original lime-based mortar suggesting that decay in the roll is either due to incorrect cutting of the stone, or localised water washing.

5.04 Brick removed next to decayed roll moulding

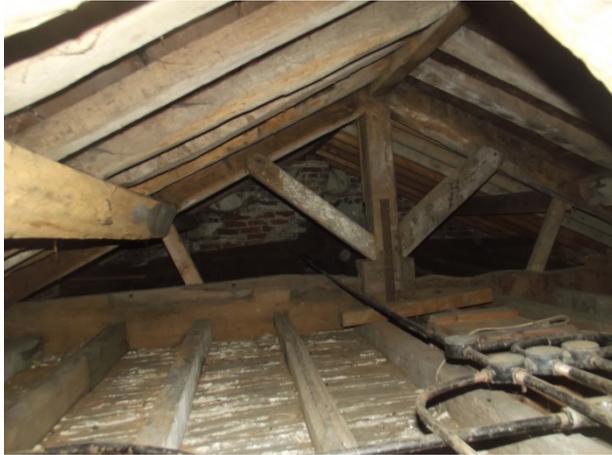
5.05 Interior of Chancel roof

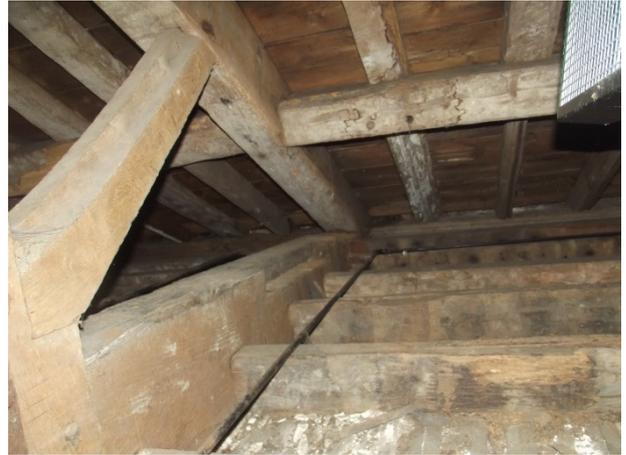
5.06 Medieval wallplate reused

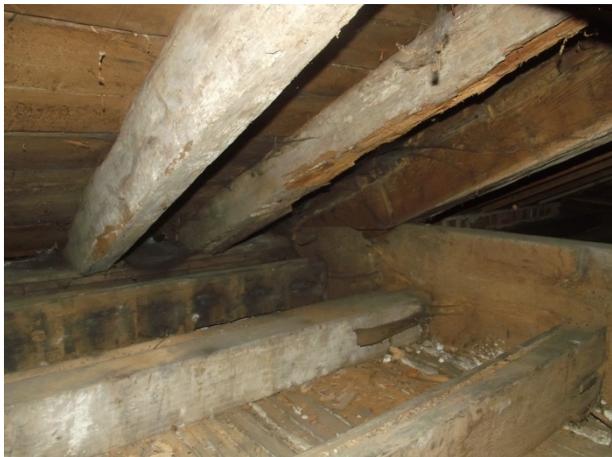
5.07 Beetle decay in rafter

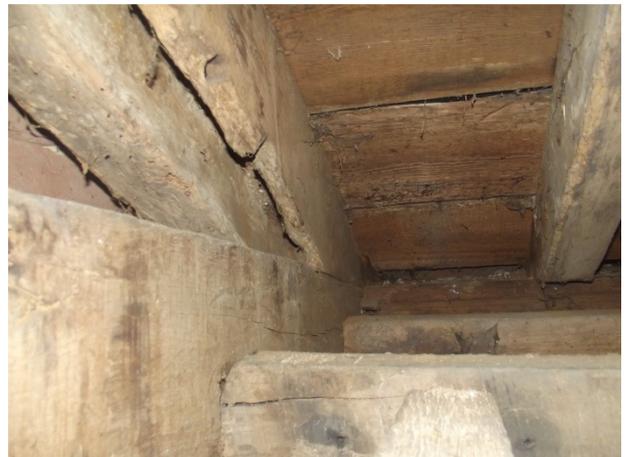
5.08 Old mortice cut in principal rafter

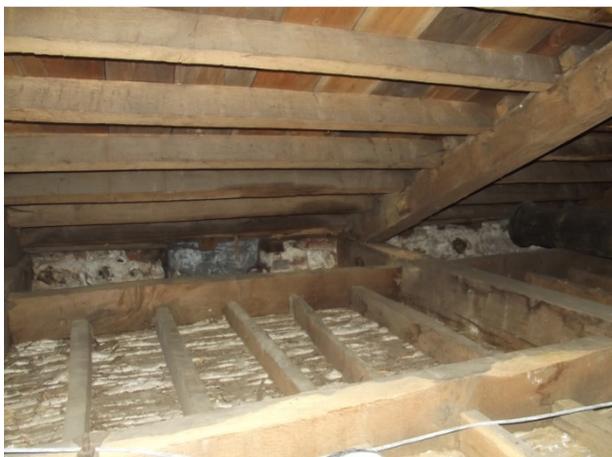
This was set into the masonry of the wall which had been built quite tightly around it. The end of the truss is damp, soft and decayed throughout its section. Although the wallplate and bearing are set inside the roof and away from the gutter it is likely that decay has spread through the interior of the section.

5.09 North end of Nave roof truss built into masonry

The boarded north gutter of the Nave should be removed, exposing all structural timbers. It is proposed to cut back the masonry from around the decayed timber and secure the six truss ends by plating the tie-beams with stainless steel angles bearing on padstones cast into the wall. A new gutter should be framed up and boarded out to the correct falls, steps and bay lengths whilst ensuring the area below is contiguous with the main roof space.

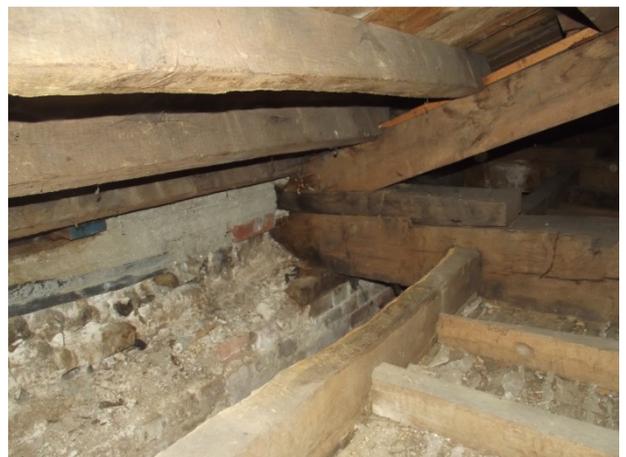
This revealed an inserted plate, introduced into the truss to support the foot of the principal rafter when the tie beam was cut back from the wall. The plate bears on a wallplate that is fully encased by the cement screed although it, and the inserted plate appear sound. The inserted plate has been severely cut down and back to allow the gutter line to be maintained leaving very little bearing. There is an inner wallplate visible from within the roof which supports the tie beam end but it is not clear how far the support of the truss relies on the bearing of the inserted timber. As noted, the end of the tie beam had been cut back, clear of the south wall and treated with a mayonnaise paste.

5.10 South end of Nave roof truss cut back and treated.
Plate inserted to carry foot of principal rafter

The screeded south gutter of the Nave should be broken out and removed, exposing all structural timbers. It is proposed to secure the six truss ends by plating the tie-beams with stainless steel angles bearing on padstones cast into the wall. A new gutter should be framed up and boarded out to the correct falls, steps and bay lengths whilst ensuring the area below is contiguous with the main roof space.

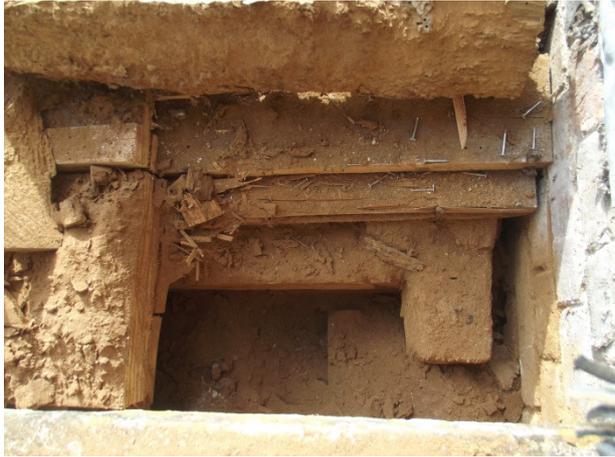
In the NW corner of the Chancel a supplementary gutter board has been introduced. This comprises two layers of plywood totalling 50mm thick. Its removal exposed the remains of the earlier boards and open eaves space. Again there was a considerable amount of debris and frass in the void and there was also a section of timber cut from the medieval moulded wallplate which was very badly decayed by beetle. All was cleared away to expose the truss end. The back of the parapet wall was hollowed out below the gutter but it was not clear why.

As with the SW corner the Truss end is supported clear of the parapet wall and, although it has a considerable number of beetle flight holes they are clearly of great age and not active. The timber is very hard and could not be readily penetrated by a drill.

5.11 NW corner of Chancel gutter opened.

The Chancel gutters should be opened, all remaining boarding removed and the voids cleared. New gutters should be framed up and boarded out to the correct falls, steps and bay lengths whilst ensuring the area below is contiguous with the main roof space. Provision should be made for the repair of one truss end but it is hoped that this will not be required.

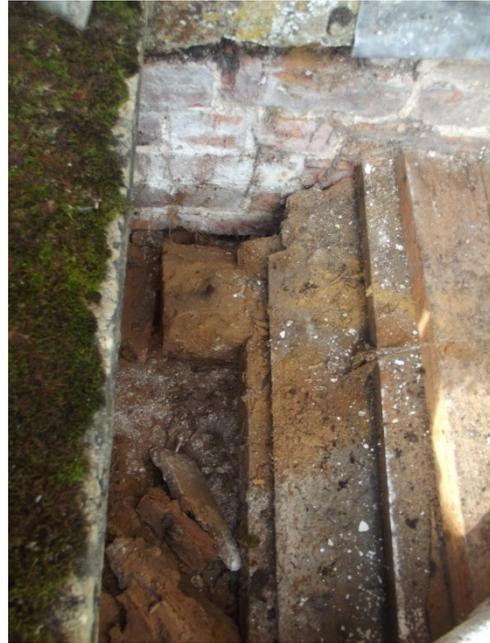
In the SW corner of the Chancel the gutter boards and supports were heavily decayed and had been largely lost. This left the lead unsupported and the void filled with frass and decayed material. The detritus was cleared away to expose the structural timbers.

The Truss end is supported clear of the parapet wall and, although it has a considerable number of beetle flight holes they are clearly of great age and not active. The timber is very hard and could not be readily penetrated by a drill.

5.12 SW corner of Chancel gutter opened

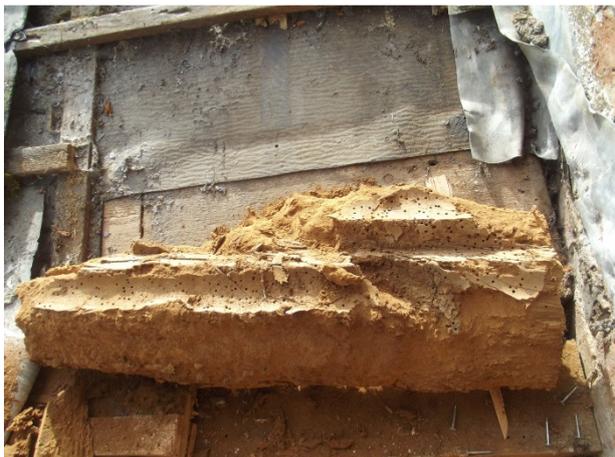
5.13 Decayed off cut of wallplate recovered from void in NW corner of Chancel

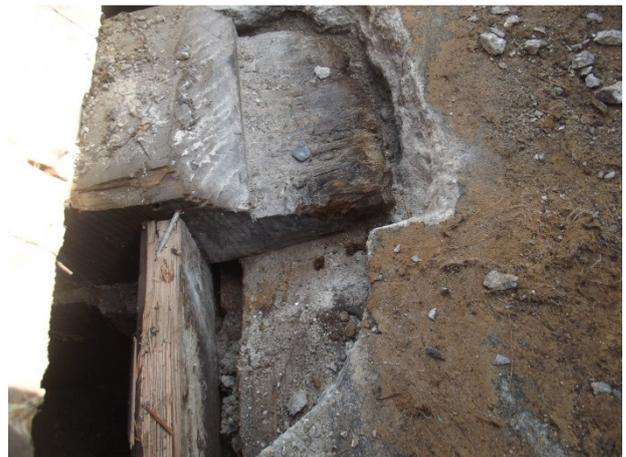
The lead of the bay immediately east of the SW sump on the Nave gutter was turned back exposing underfelt and cement screed laid to falls. The truss end appeared to be encased in this screed so the latter was cut away.

5.14 Cement screed cut away to expose end of inserted plate and wallplate bearing beneath.

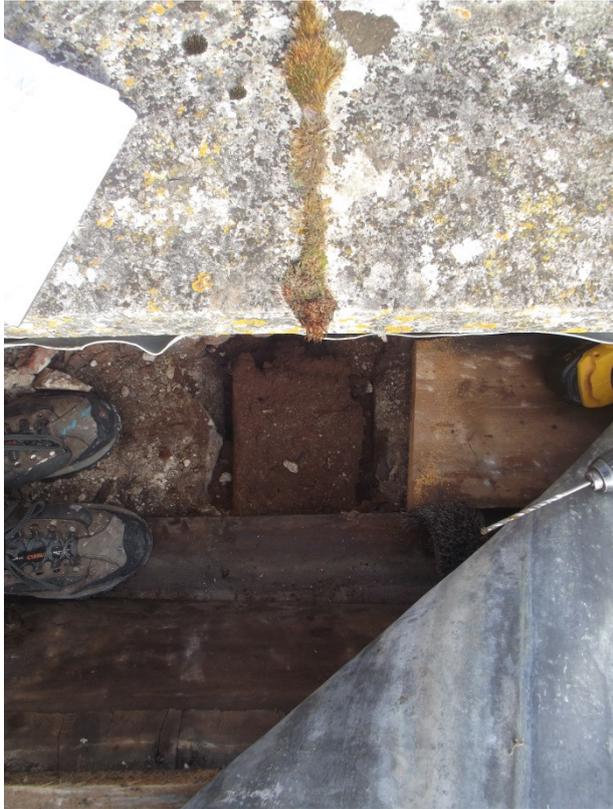
5.15 Masonry cleared away from N truss end over Nave:
Timber found to be damp and soft.
